REPORT NUMBER 214-GTL-04-002

**SAFETY COMPLIANCE TESTING FOR  
FMVSS NO. 214S  
SIDE IMPACT PROTECTION (STATIC)**

**HYUNDAI MOTOR COMPANY  
2004 HYUNDAI XG350, PASSENGER CAR  
NHTSA NO. C40500**

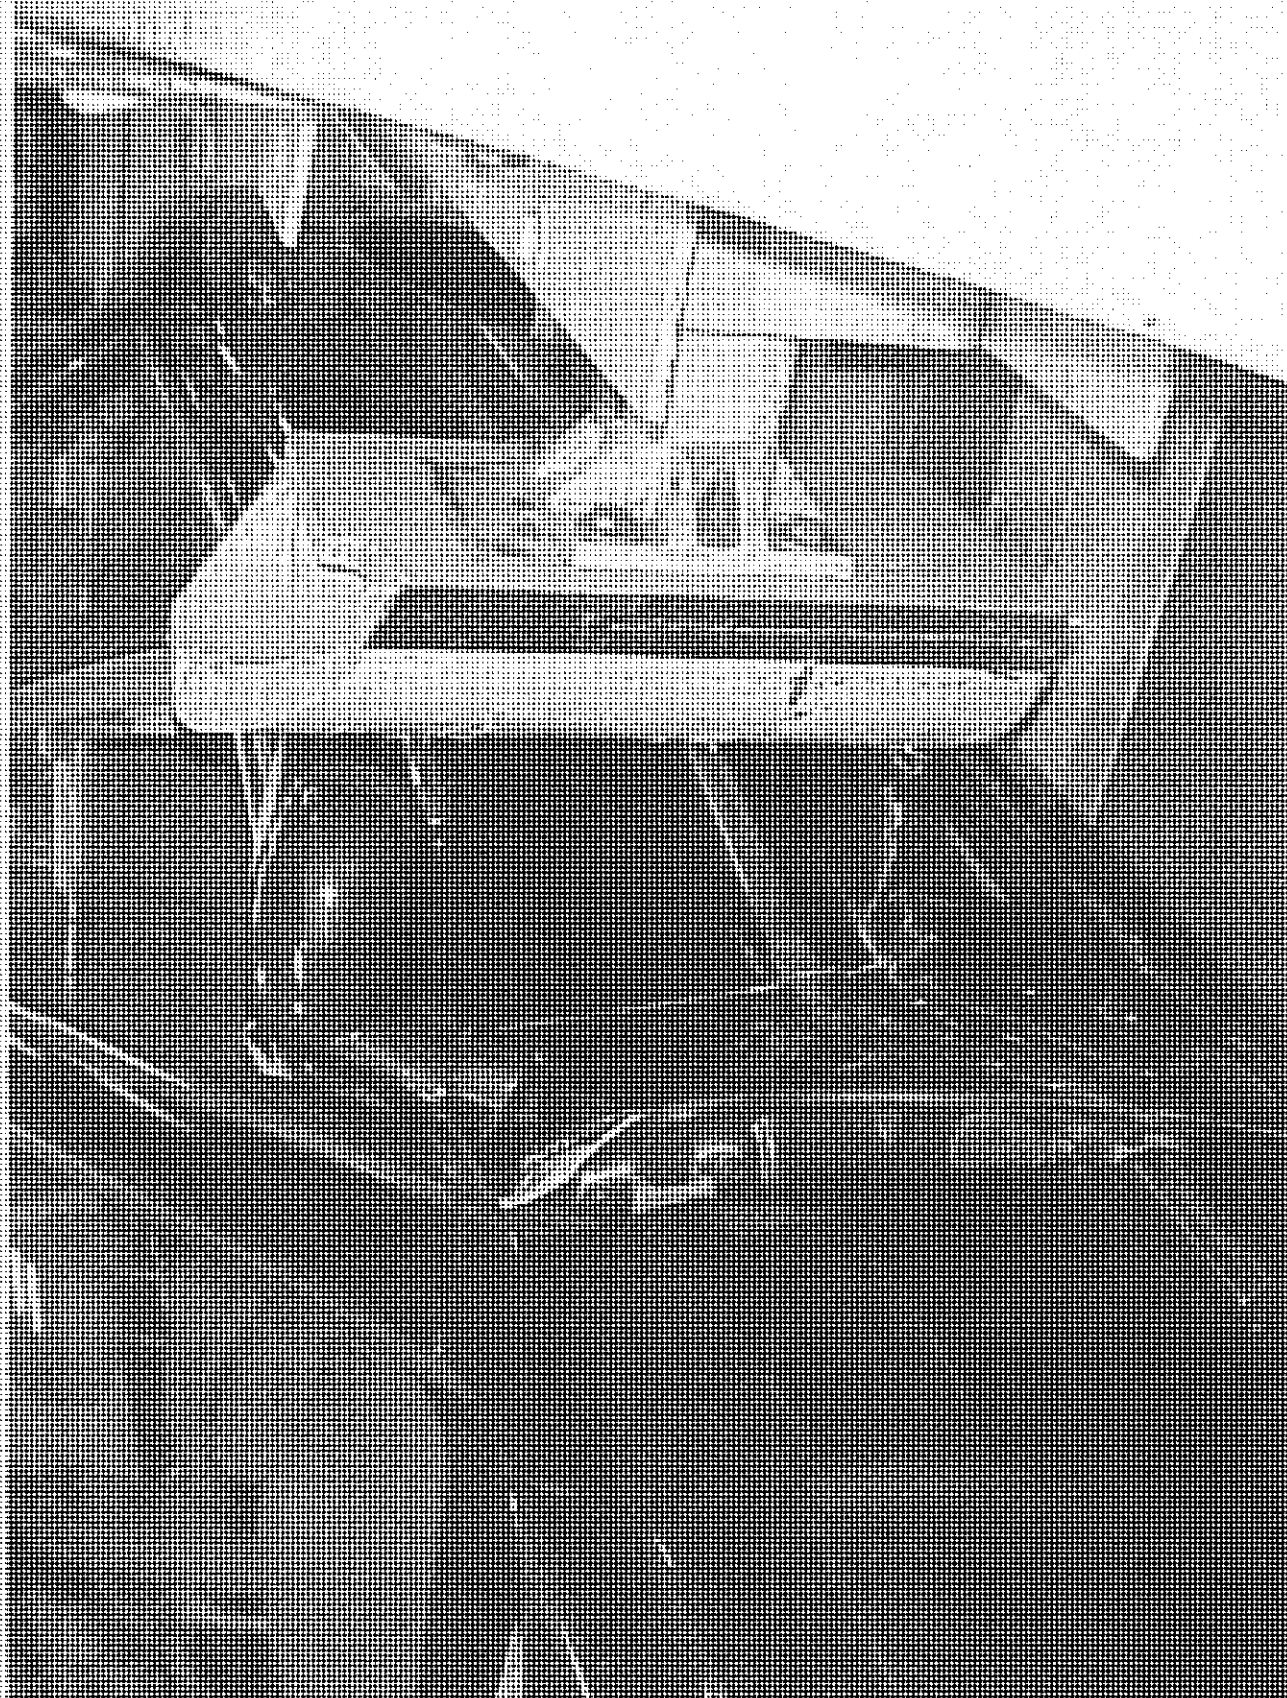
FIGURE 5.19  
POST TEST DOOR OUTSIDE - TEST 1
